U.S. 301 PROJECT DEVELOPMENT

DETERMINATION OF ELIGIBILITY REPORT

Volume IV

Volume IV: Narratives and CRS Forms for N14358 to N14397

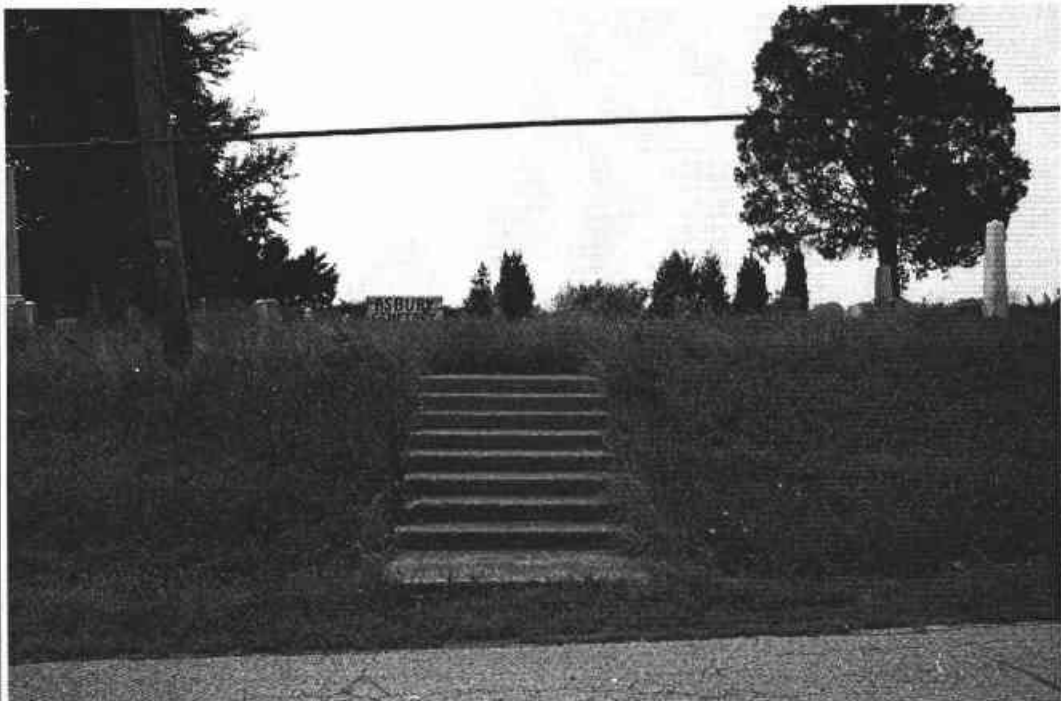
N14358. Photograph 1. Asbury Cemetery, overview showing stair entrance from road, looking west.

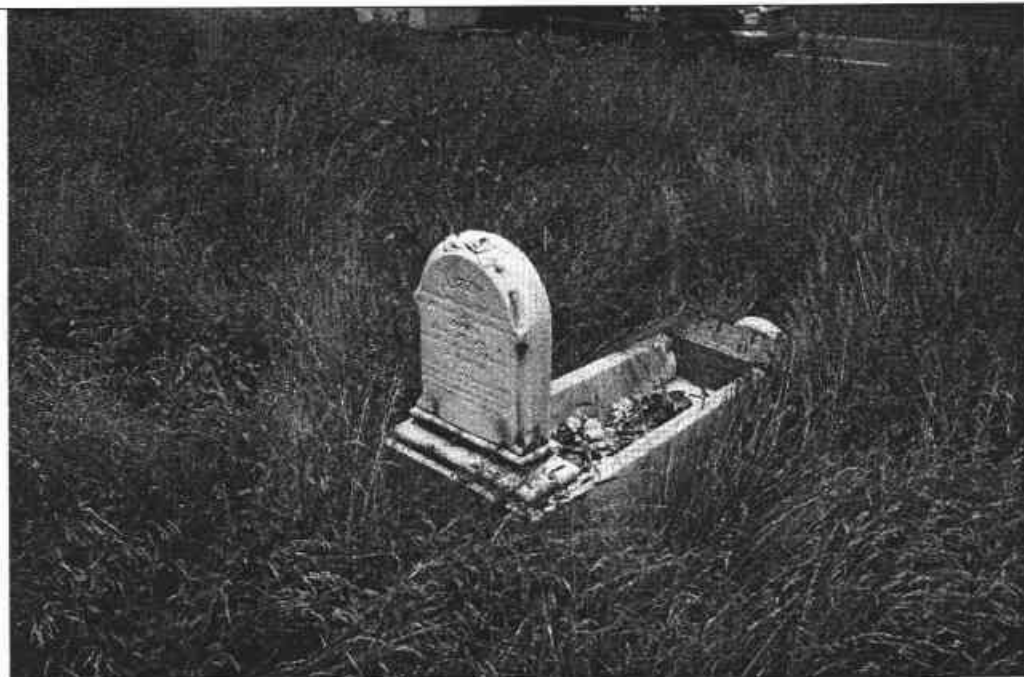
N14358. Photograph 2. Asbury Cemetery, showing headstone and marker; note proximity of highway with truck in background.

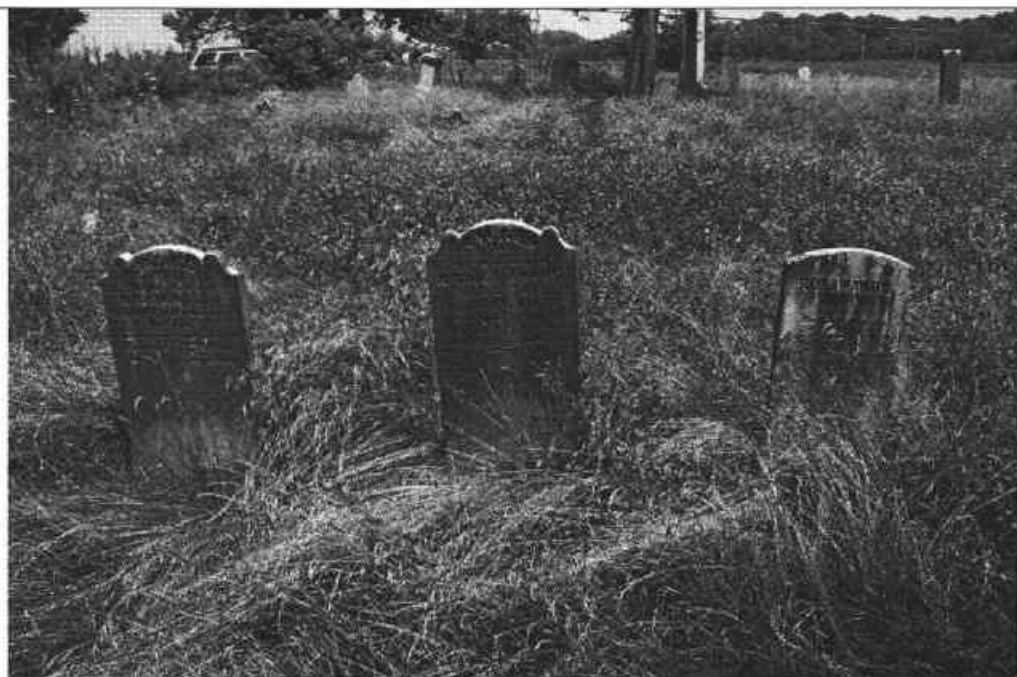
N14358. Photograph 4. Asbury Cemetery, showing typical example of markers located in the western portion of the cemetery, view looking northeast.

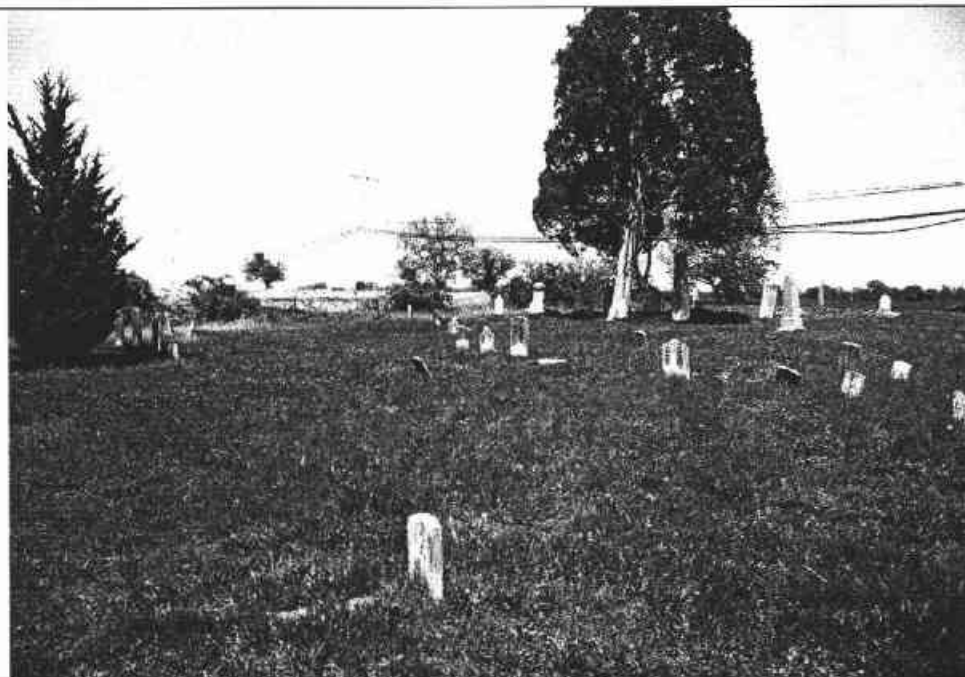
N14358. Photograph 5. Overview of the cemetery from the southwest quadrant, view looking northwest.

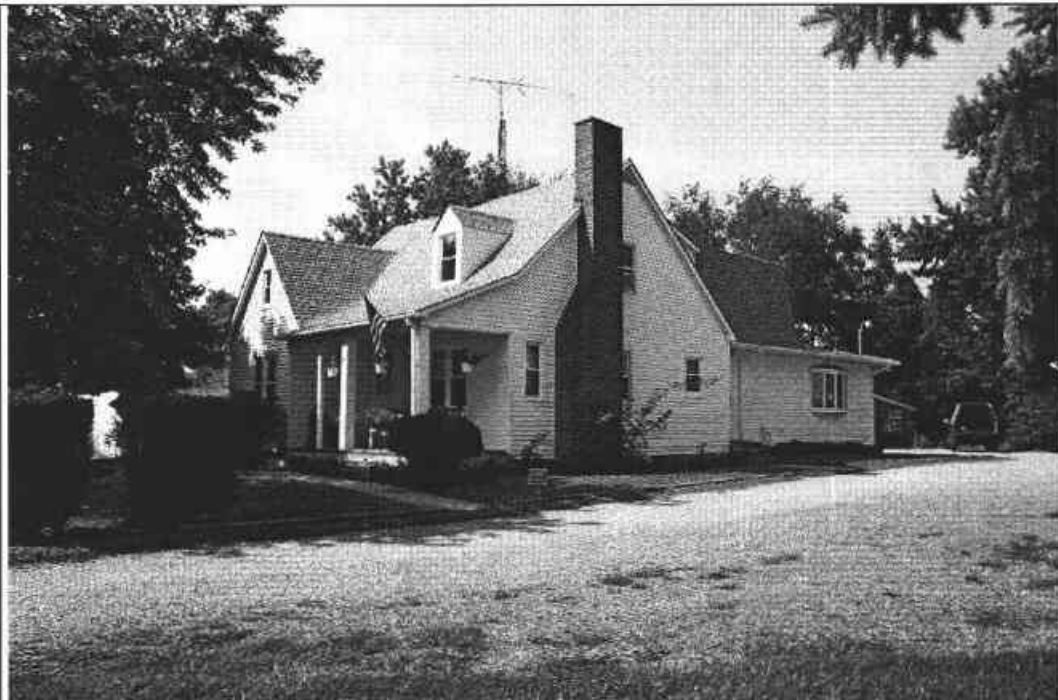
N14359. Photograph 1: William and Mary Hitch House, south and east elevations, view to northwest. Note vinyl siding, replacement windows, and large addition extending from north elevation.

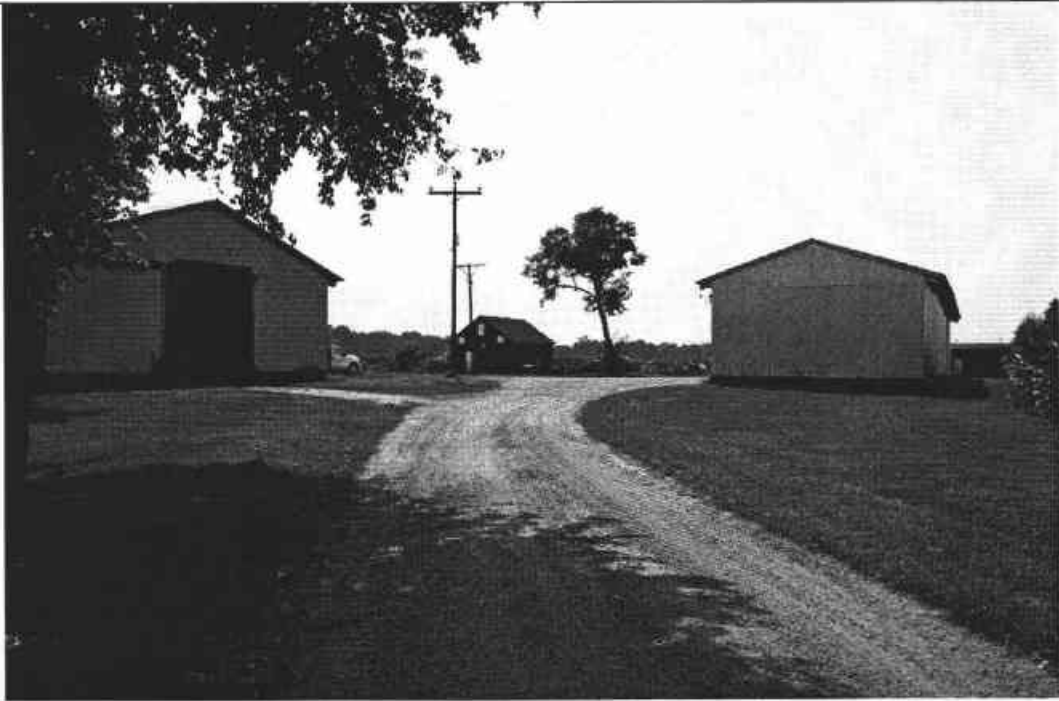
N14360. Photograph 1: Overview of farm complex at end of gravel driveway, view to southwest. Note hay barn to left, equipment shed and corncrib/granary in middle, and equipment shed to right.

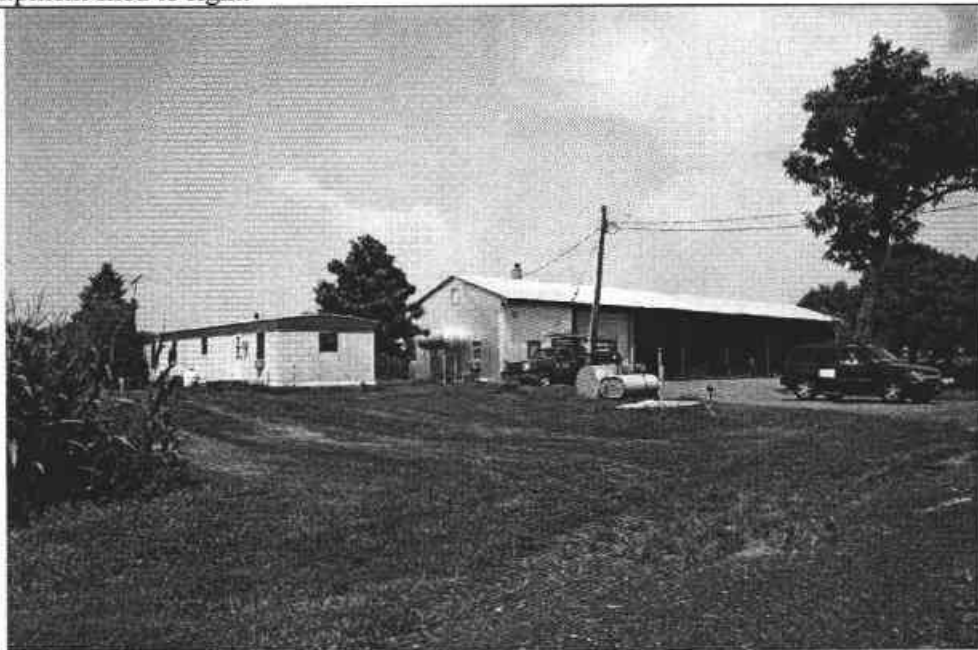
N14360. Photograph 2: Trailer and office/equipment shed, view to northeast.

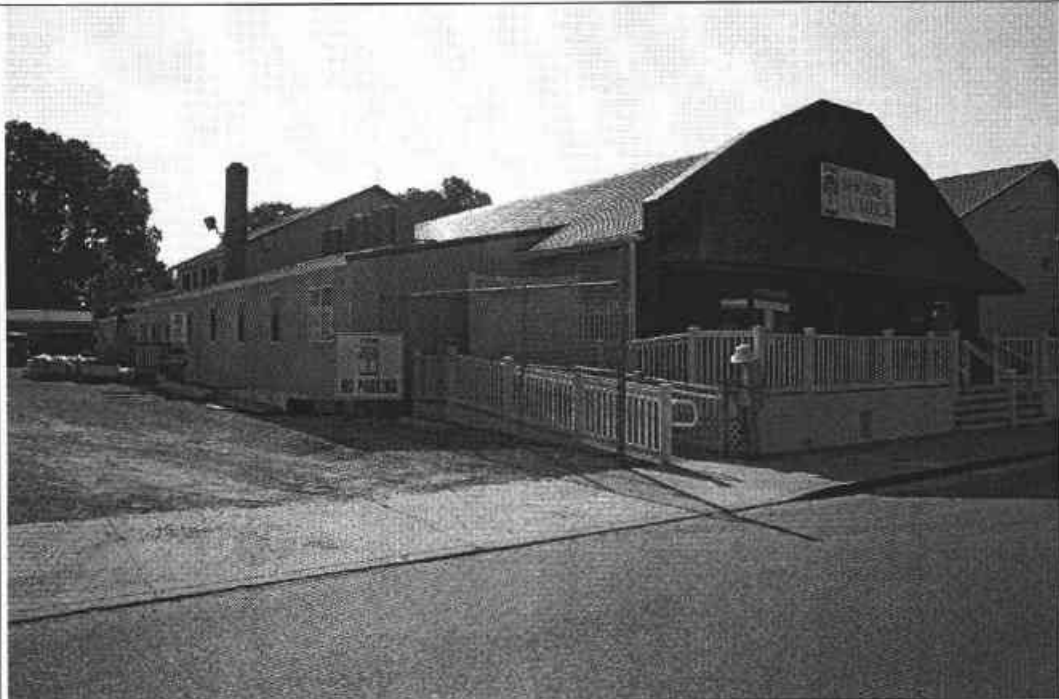
N14361. Photograph 1. Short & Wall Lumber Company, view looking southeast, showing west and north elevations. Note modern pent roof, modern handicap access ramp, modern deck, and replaced windows.

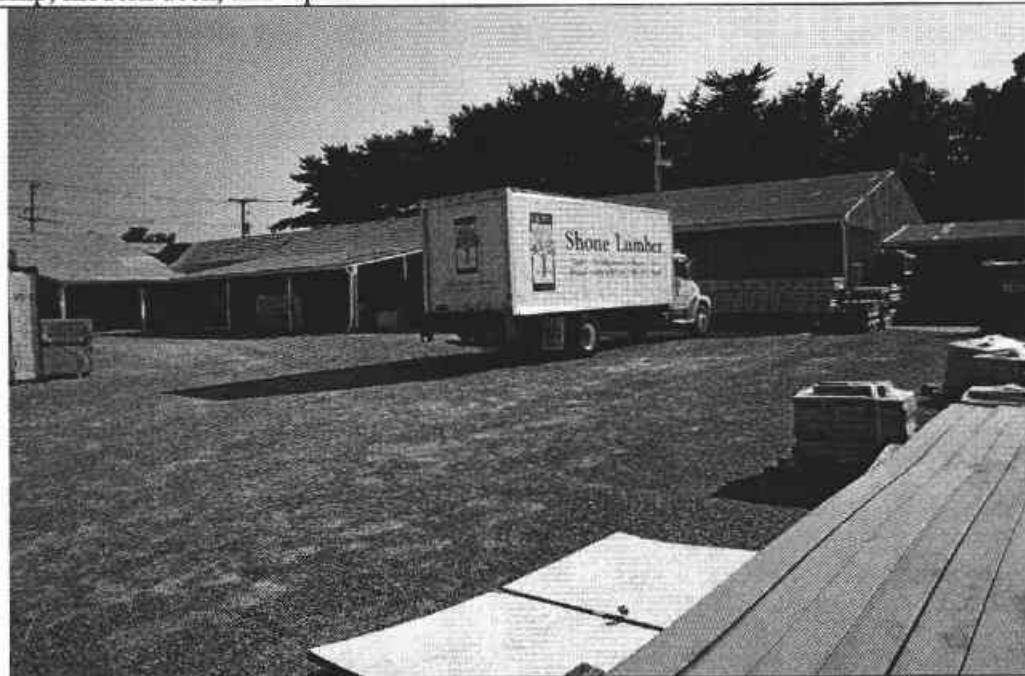
N14361. Photograph 2. Short & Wall Lumber Company, view looking east, showing modern sheds in lumberyard area.

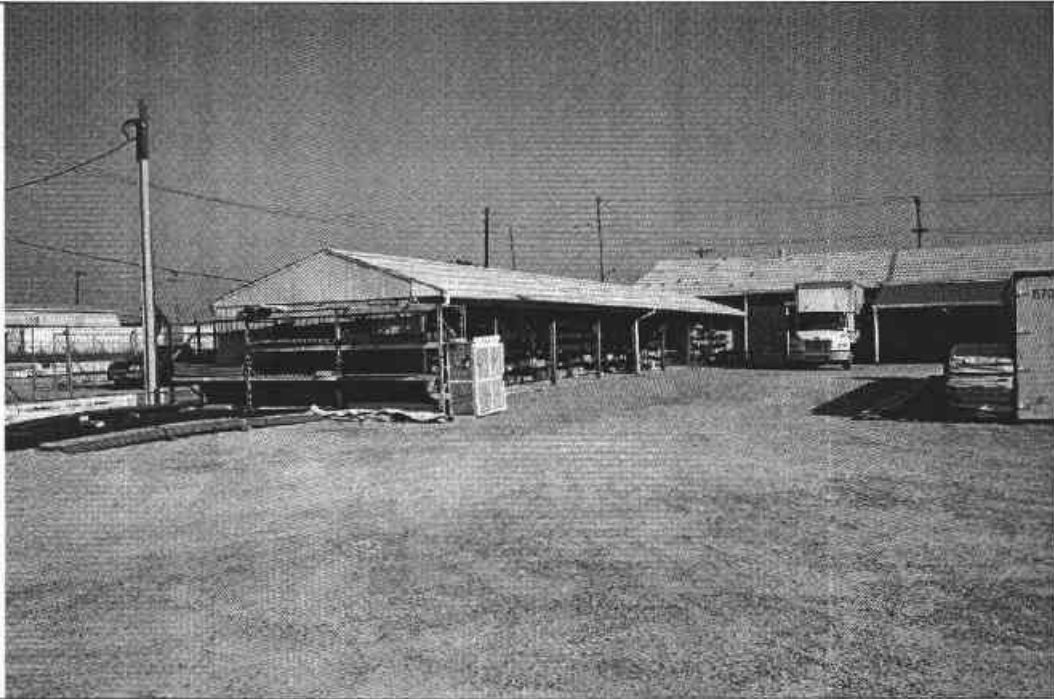
N14361. Photograph 3. Short & Wall Lumber Company, view looking north, showing modern sheds in lumberyard area.

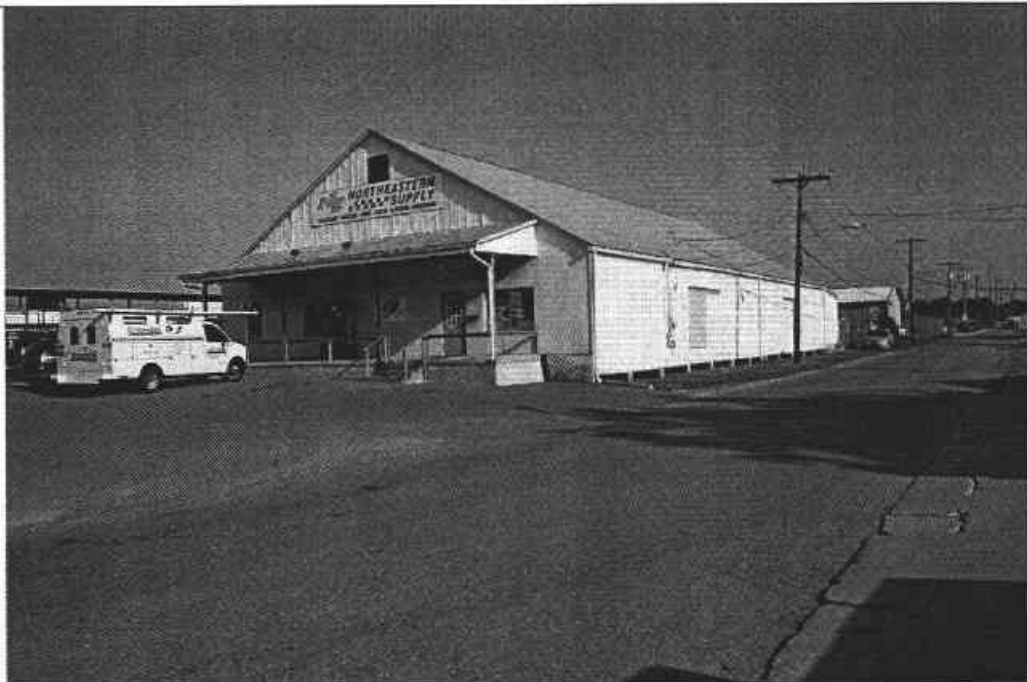
N14362. Photograph 1. 225 West Main Street, view looking northwest, showing south and east elevations of former fertilizer warehouse, now serving as a retail store (Northeastern Supply). Note replacement deck, and modern/replaced fixed-pane window and pedestrian door, and louvered opening in gable end.

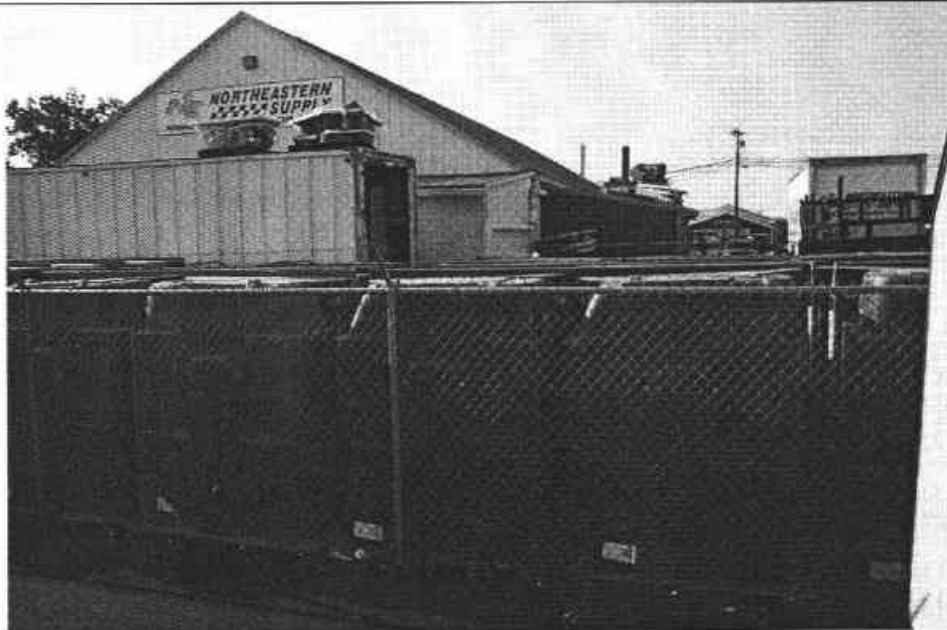
N14362. Photograph 2. 225 West Main Street, view looking south, showing former fertilizer warehouse, north and partial east elevations. The north and east side the building is used for outside storage; note trailers and hot tubs in foreground.

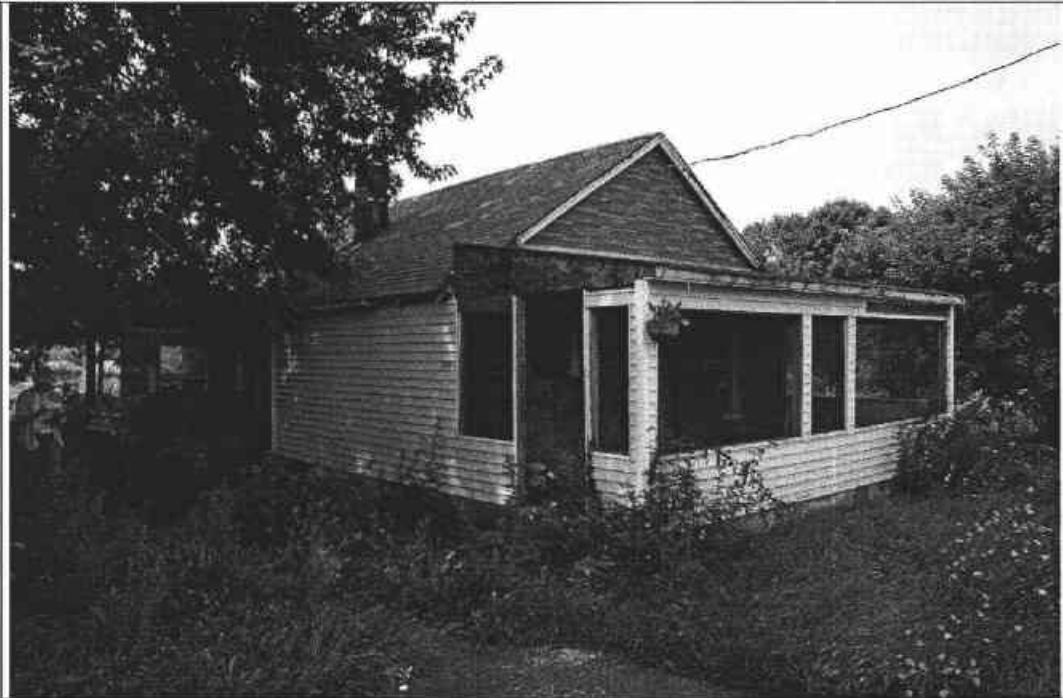
N14363. Photograph 1: Dwelling, north elevation, view to southwest. Note the enclosed front porch and vinyl siding.

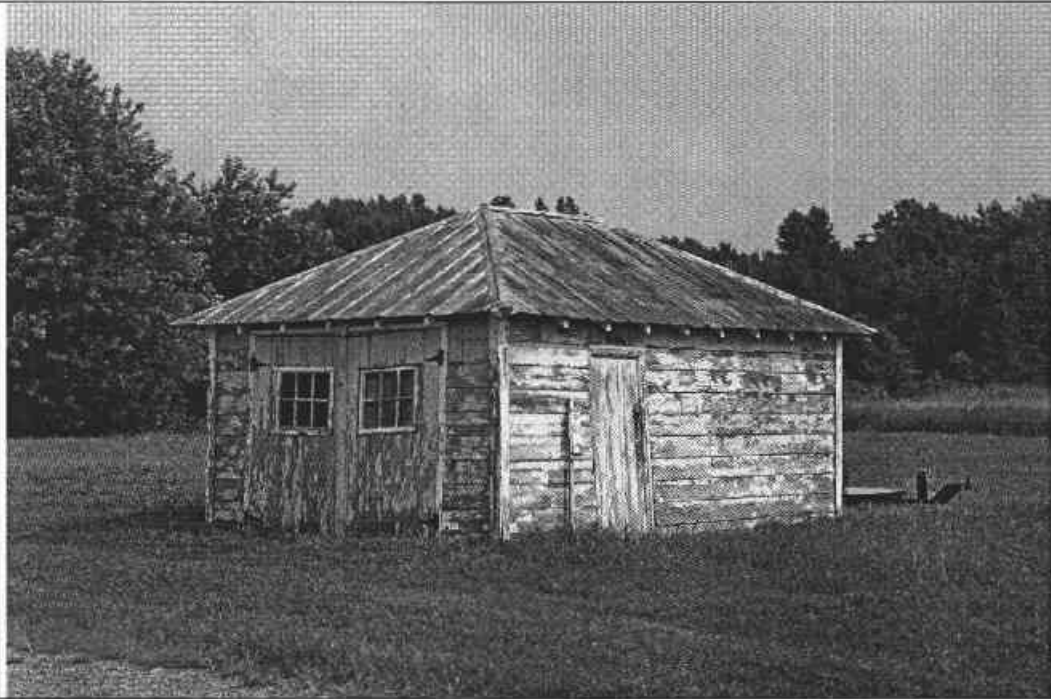
N14364. Photograph 1: Garage, view of north and west elevation. The garage is located behind a modern building. It is unclear if this building is original to the property.

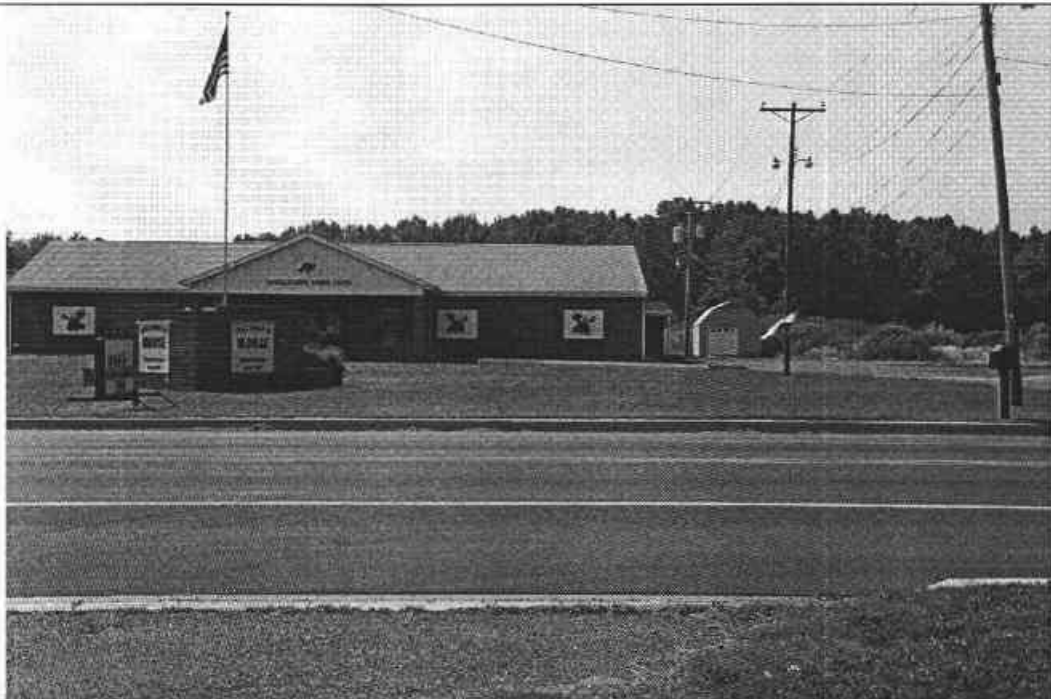
N14364. Photograph 2: Overview of Middletown Moose Lodge, view looking south. Note modern shed to the right side of the building.

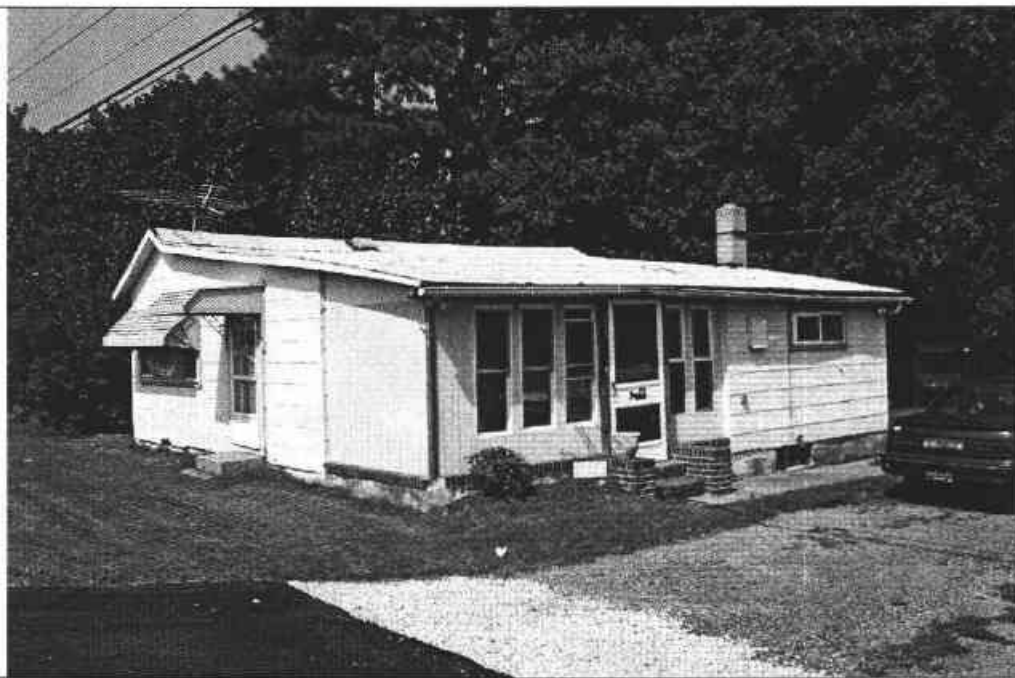
N14365. Photograph 2: Dwelling, west and south elevations, view to northeast. Note the *circa*-1970 enclosed porch and secondary entrance on the south elevation. .

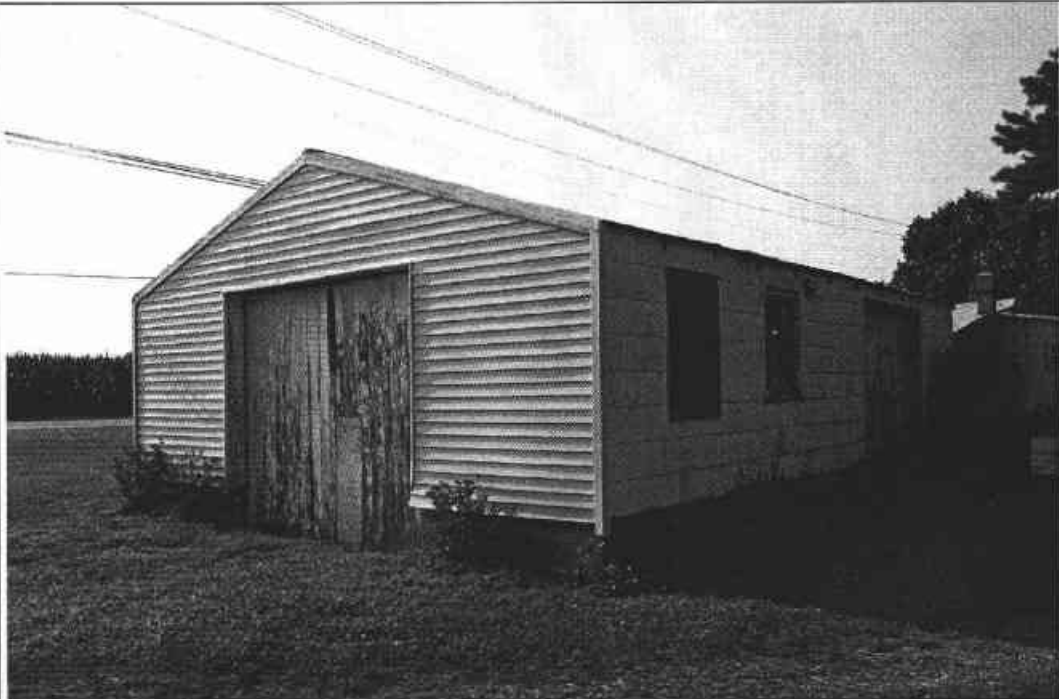
N14365. Photograph 3: Garage, south and east elevations, view to northwest. Note the vehicle openings on each elevation and the replacement vinyl siding on the south elevation.

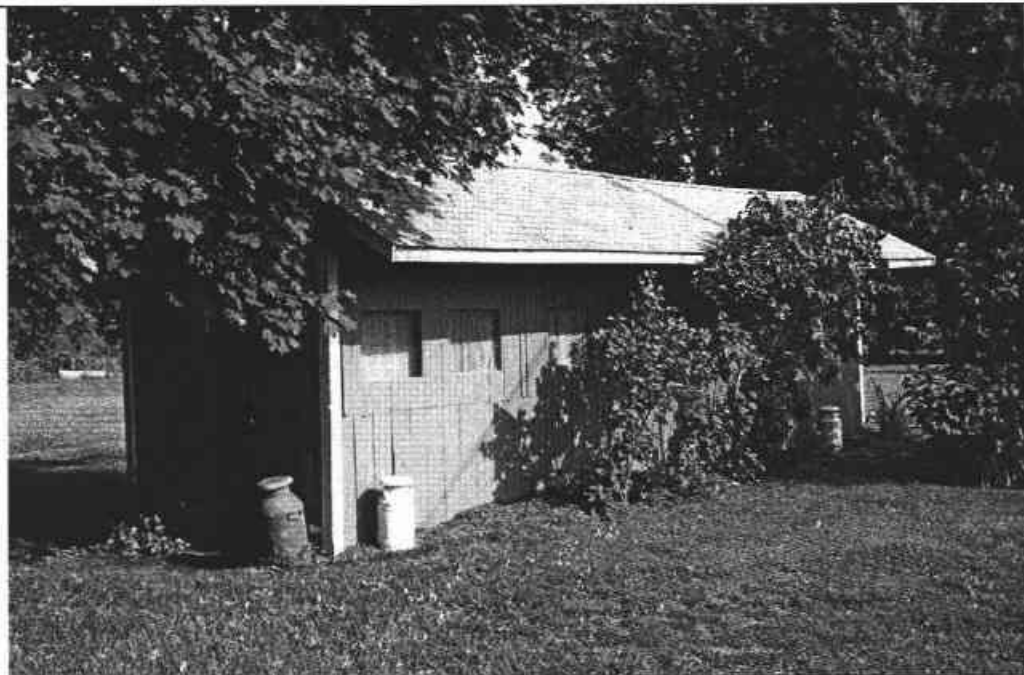
N14365. Photograph 4: Carnival shed, north and west elevations, view to southeast. The shed was likely moved to the property shortly after construction of the dwelling.

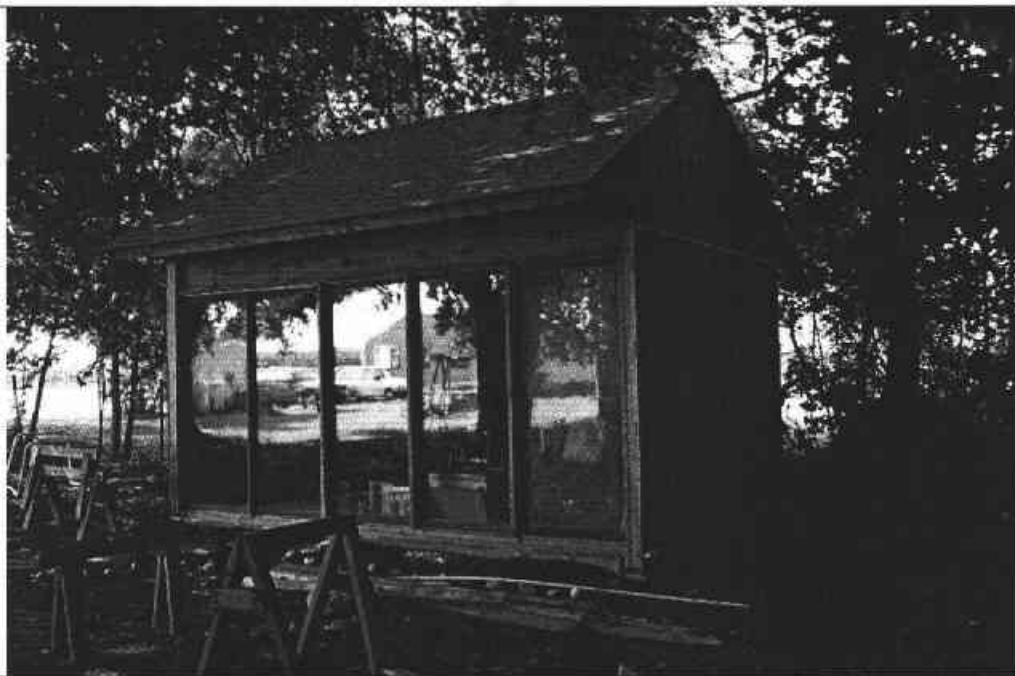
N14365. Photograph 6: Chicken house, south and east elevations, view to northwest. Note the wall of windows that has replaced the original façade. .

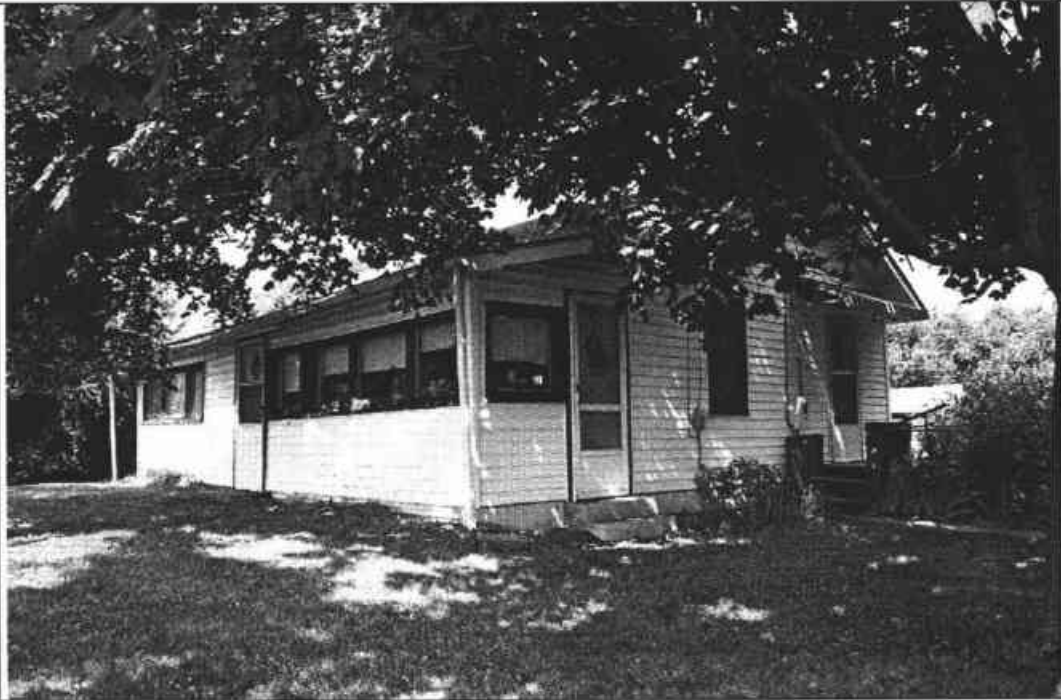
N14366. Photograph 1: Dwelling, north and west elevations, view to southeast. Note the enclosed front porch and modern cladding.

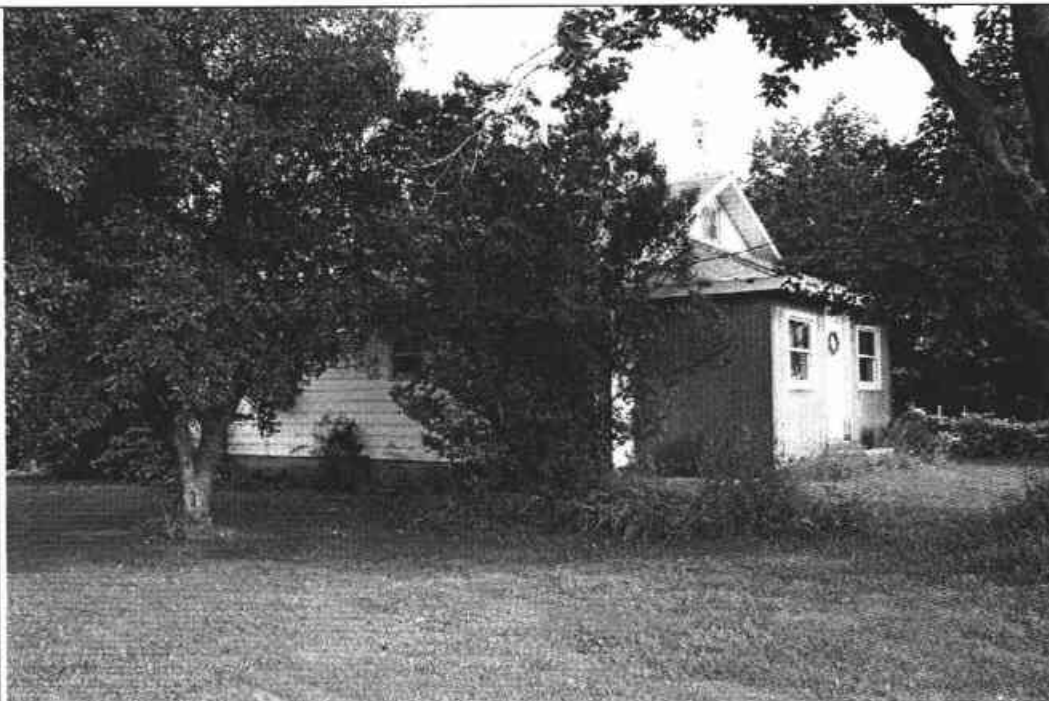
N14367. Photograph 1: Dwelling view of the north and west elevations. Note the modern cladding and the enclosed front porch.

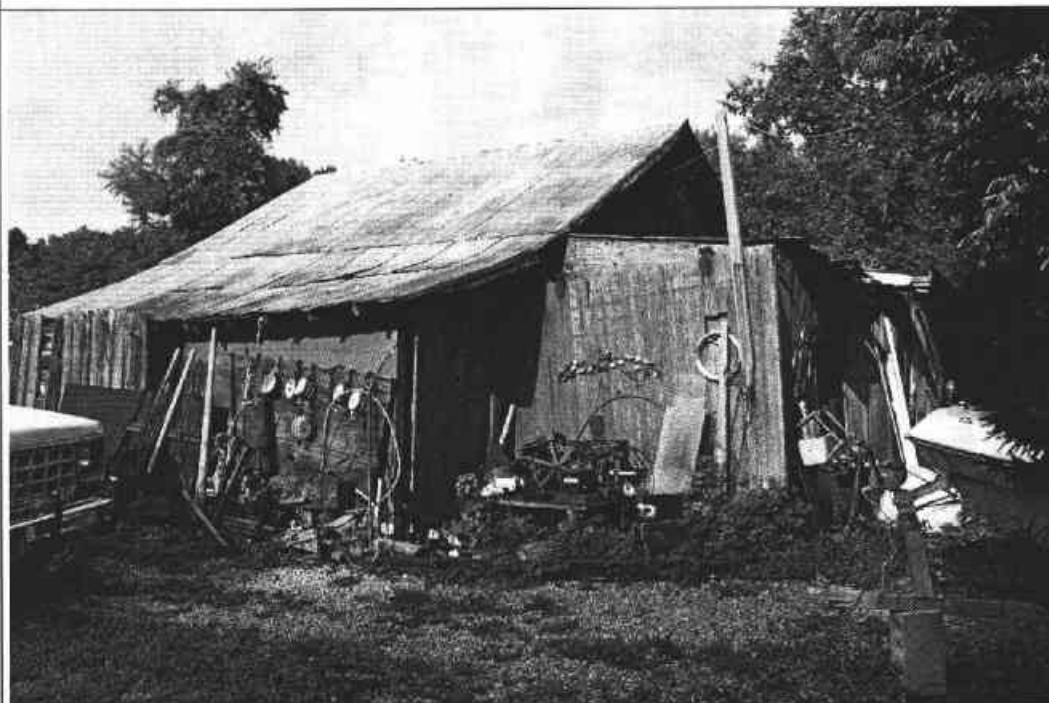
N14367. Photograph 2: Barn view of the north and east elevations. Note the multiple shed roof additions.

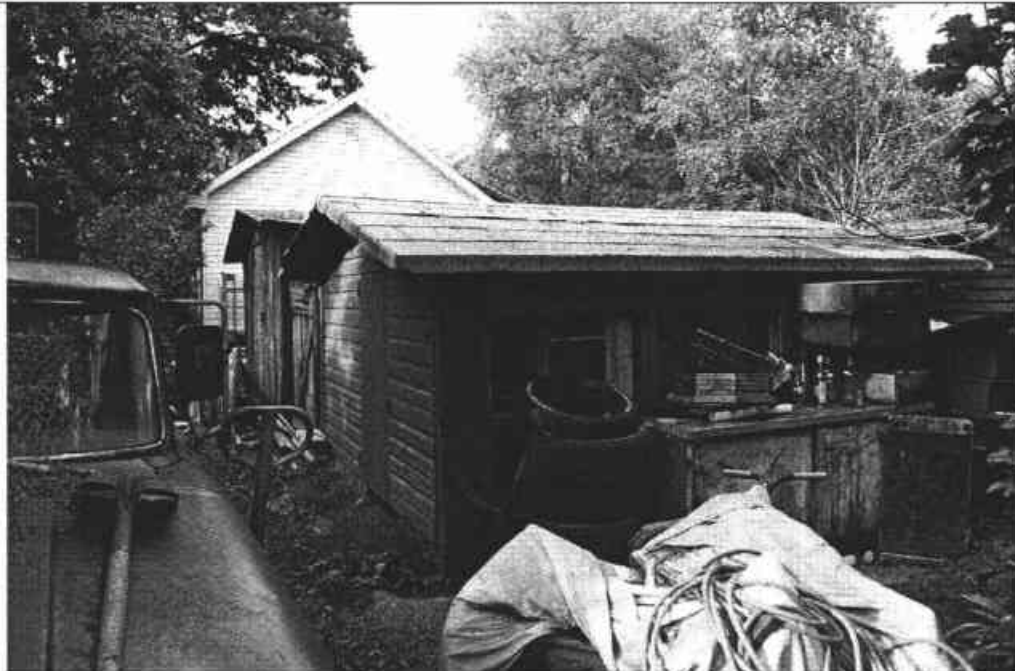
N14367. Photograph 3: View of the south and east elevations of two small storage sheds. These sheds are located to the rear of the modern dwelling.

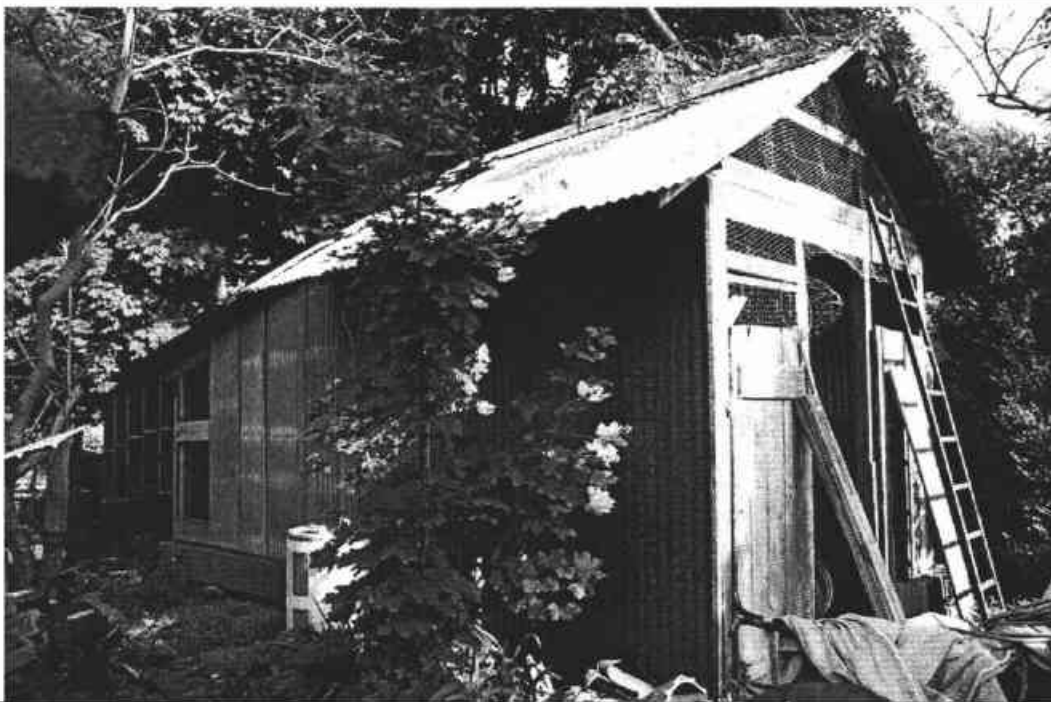
N14367. Photograph 4: Feed storage view of the north and west elevations. Note the modern materials, and dilapidated state of the building.

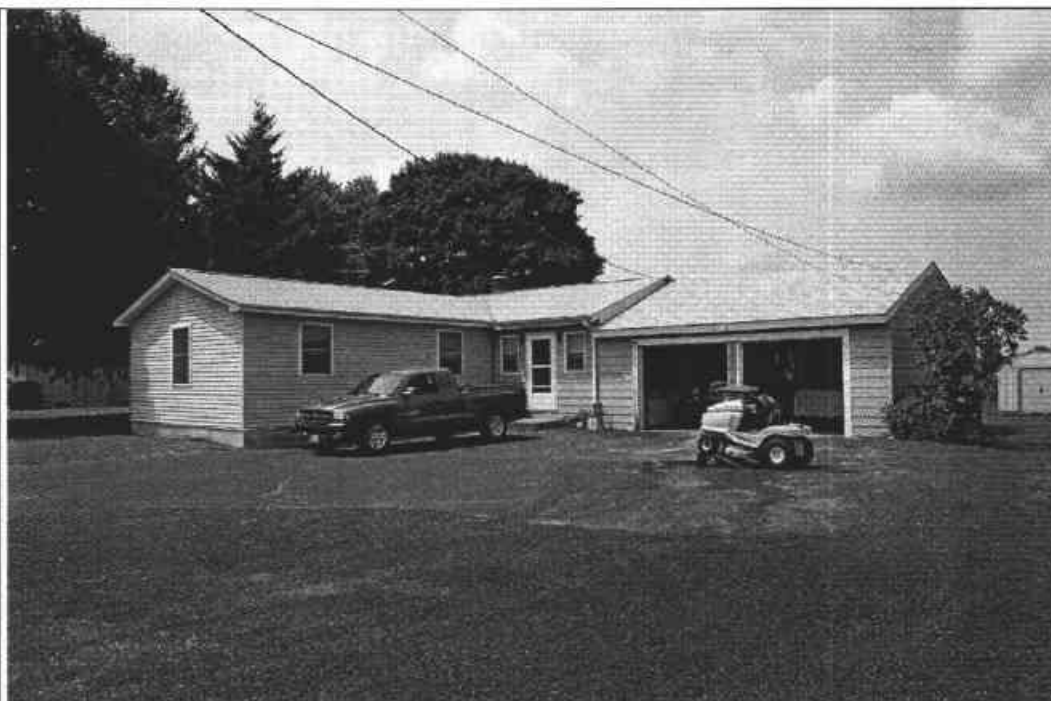
N14371. Photograph 1: Dwelling, south elevation, view facing northwest. Note the large gable addition as well as the attached garage.

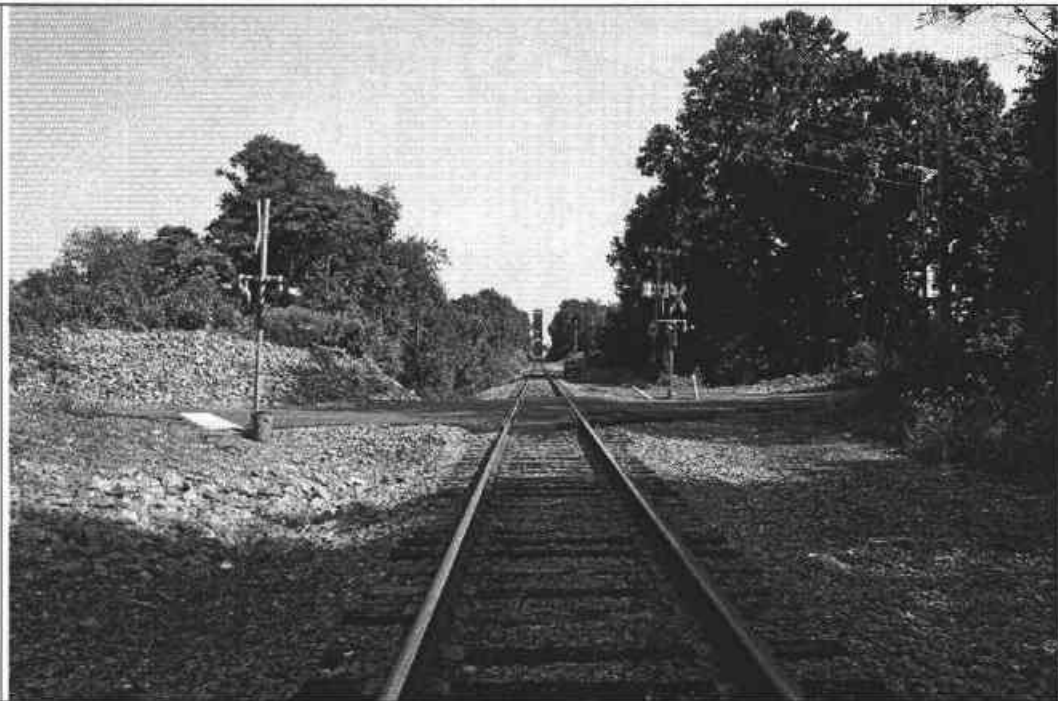
N14373. Photograph 5. Delaware Railroad. View of railroad at Lorewood Grove Road looking north, near northern end of project area. The high-swing bridge at the C & D Canal can be seen in the background.

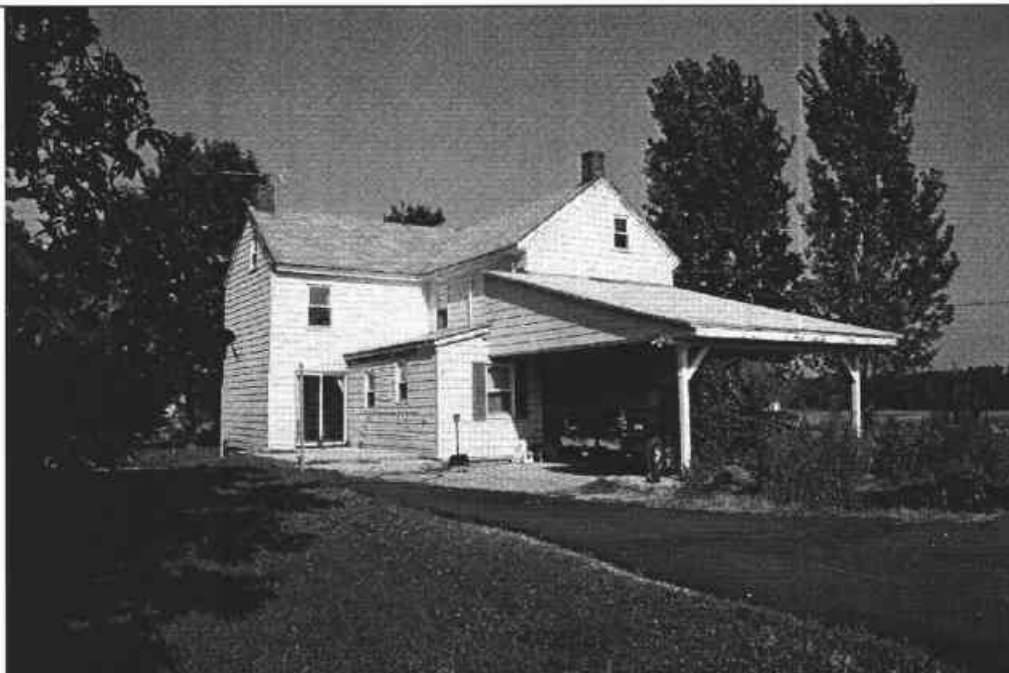
N14375. Photograph 2: Dwelling, south and east elevations, view to northwest.

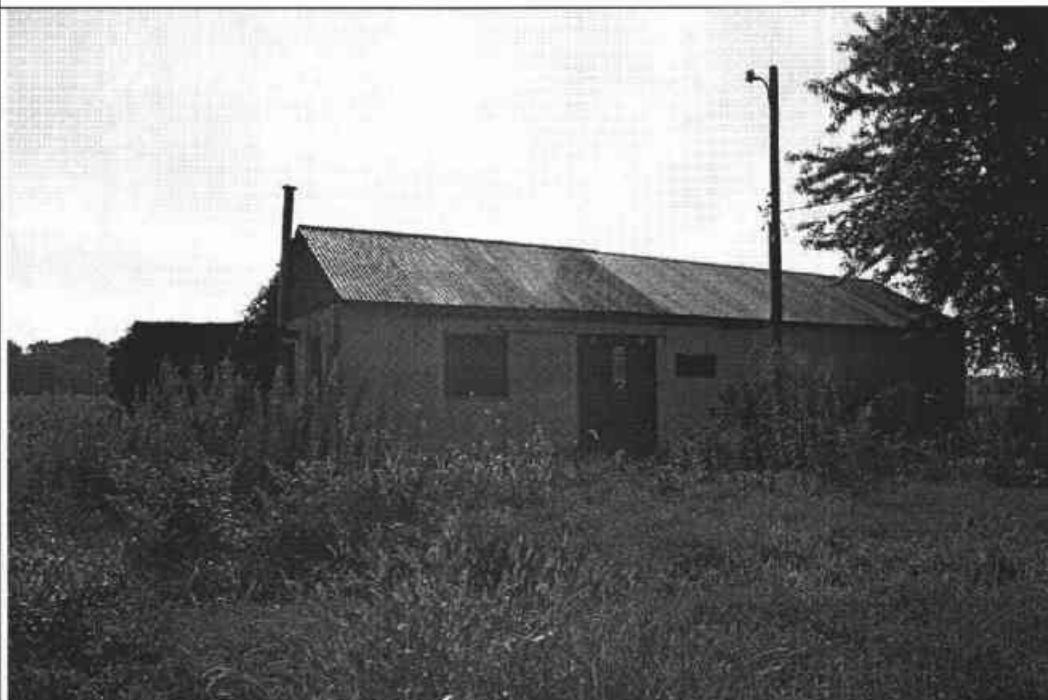
N14375. Photograph 3: Milk house, north and west elevation, view to southeast. Former barn is now gone.

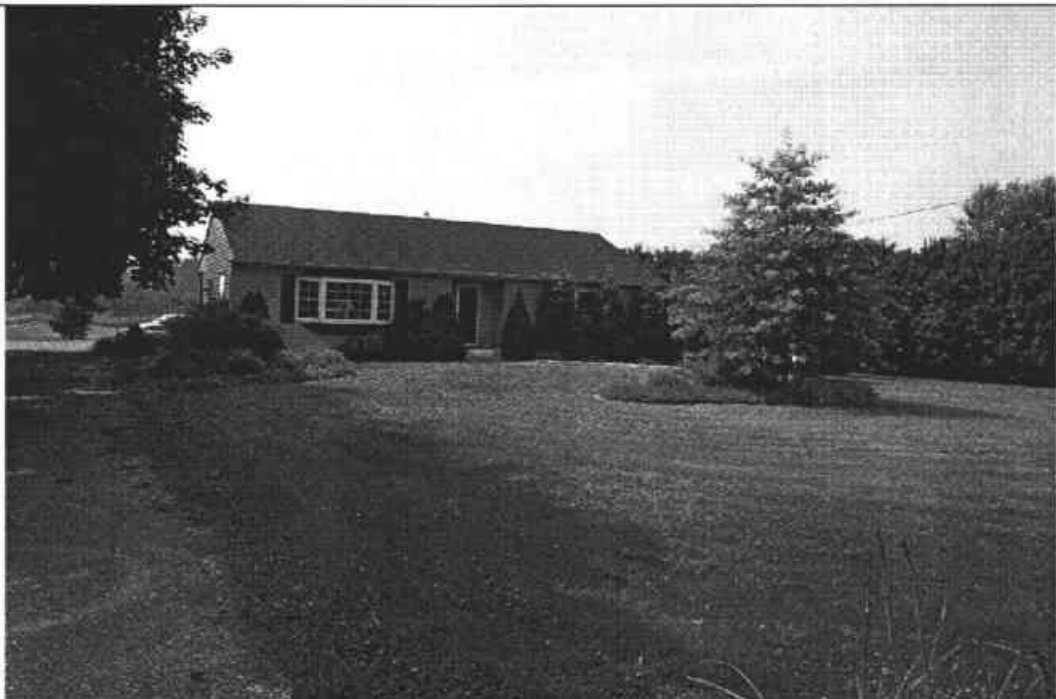
N14378. Photograph 1: Murphy House, view of façade, looking west. A two-bay garage has been added to the house onto the rear (west) elevation.

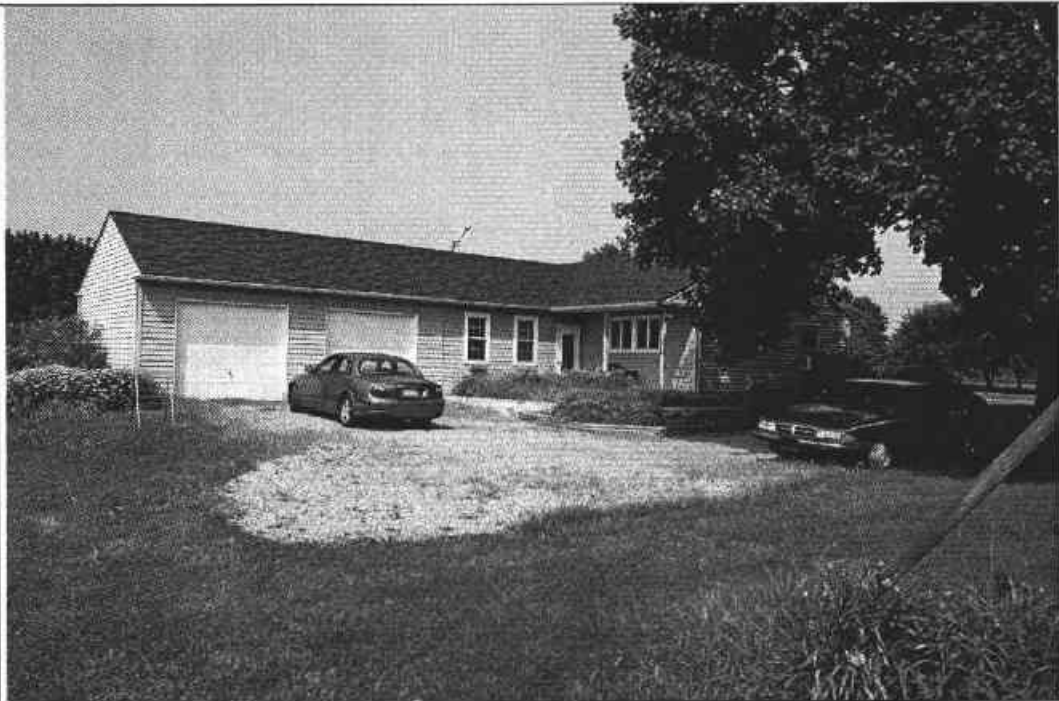
N14378. Photograph 2: View of garage addition, view looking north.

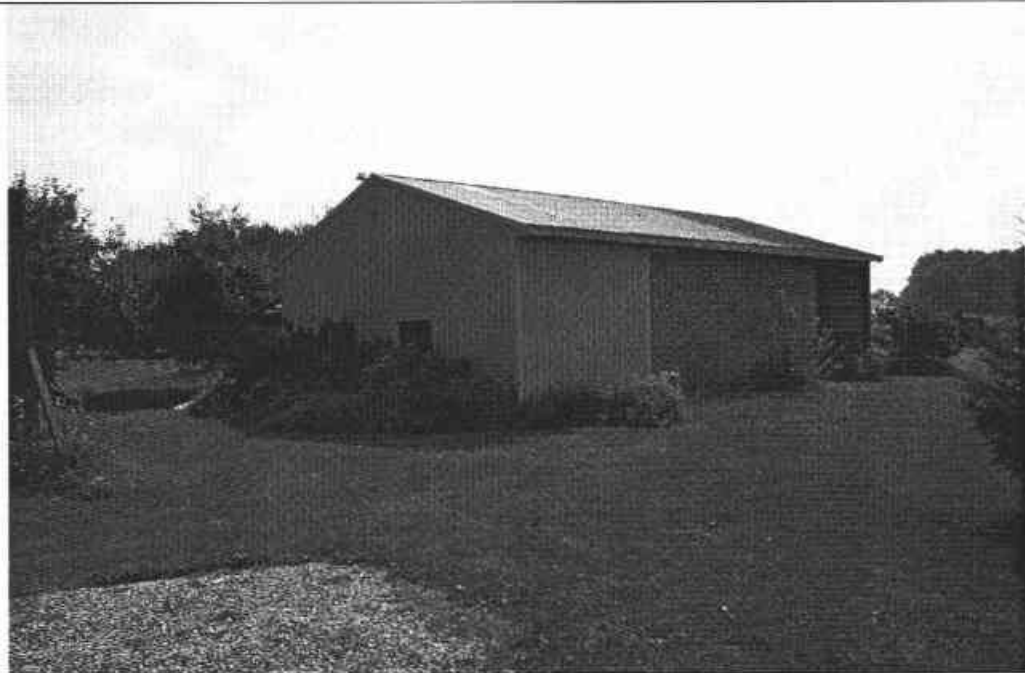
N14378. Photograph 3: View of modern pole shed.
